Urgent Field Safety Notice

Advice regarding the continued safe use of
Impella Heart Pumps

Aachen, September 20, 2018

Abiomed Europe GmbH

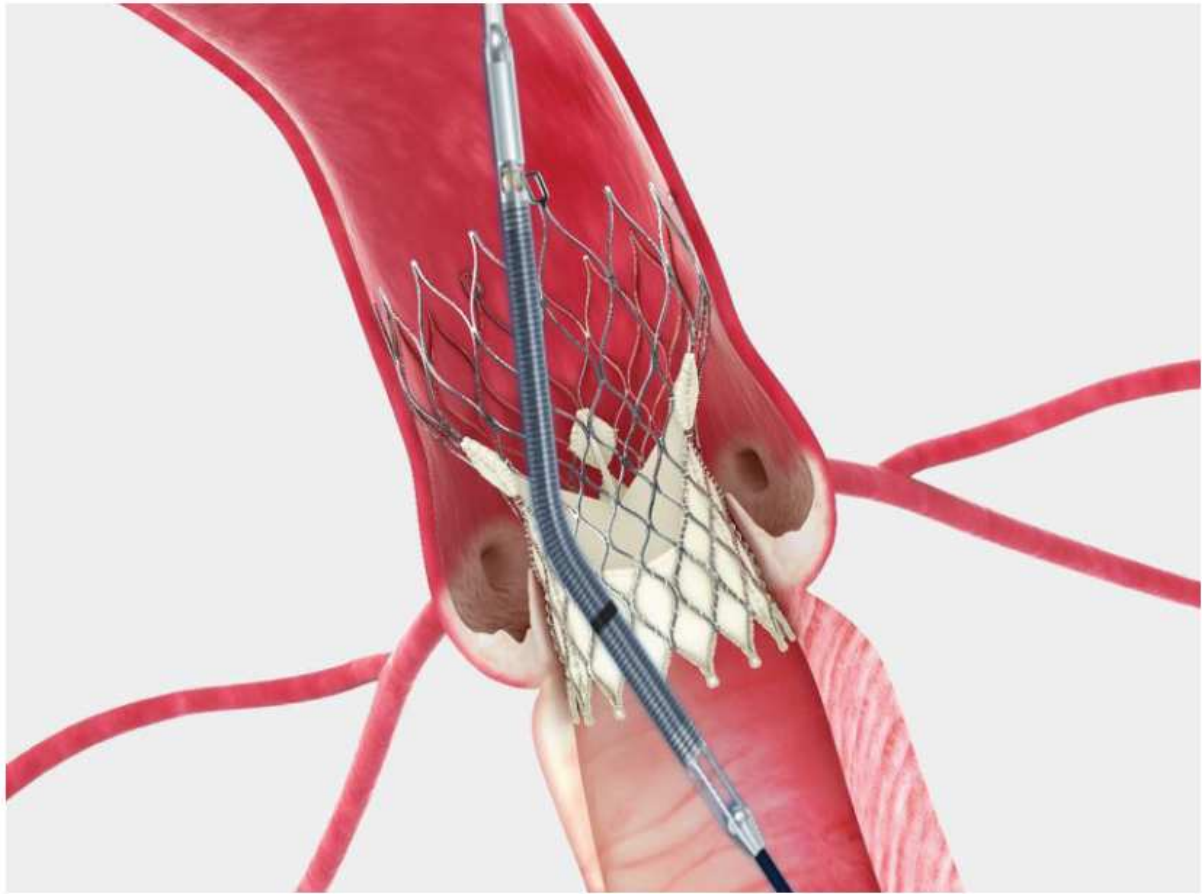
There is a potential risk for unintentional interaction of the Impella motor housing with the distal stent of a Medtronic CoreValve or Evolut R transcatheter aortic valves resulting in destruction of the impeller blades. This has resulted in low flow from the damaged Impella system.

The outflow struts of the CoreValve or Evolut R nitinol frame can enter the outlet opening of Impella and damage the impeller (see figure below). This interaction while running the pump can result in fracture of the impeller material. Although no events have been identified, systemic embolization of the fractured impeller material is a possibility.

This risk of interaction is increased for oversized or underexpanded frames with the distal ends not flush with the aortic wall, resulting in the distal stent structures oriented in such a way as to enter the outflow window and allow contact of the end of the stent with the spinning impeller.

Clinicians are cautioned to position the Impella system carefully in patients with transcatheter aortic valve prostheses, in particular the Medtronic CoreValve or Evolut R valves, and to be aware of this potential interaction. In this situation, clinicians should avoid repositioning while the device is running and should turn the device to P0 during repositioning or any movement that could bring the outlet windows into proximity to the valve stent structures.

If there is low flow observed in a patient implanted with a transcatheter aortic valve prosthesis while on Impella heart pump support, you should consider damage of the Impeller and replace the Impella pump as soon as possible.
