Welch Allyn, Inc. 4341 State Street Road Skaneateles Falls, NY 13153 USA	URGENT: Field Safety Notice	MOD1319
---	------------------------------------	----------------

Commercial name of affected product:
Welch Allyn ELI380 RESTING ELECTROCARDIOGRAPH

Type of action: Field Safety Corrective Action – Software Upgrade

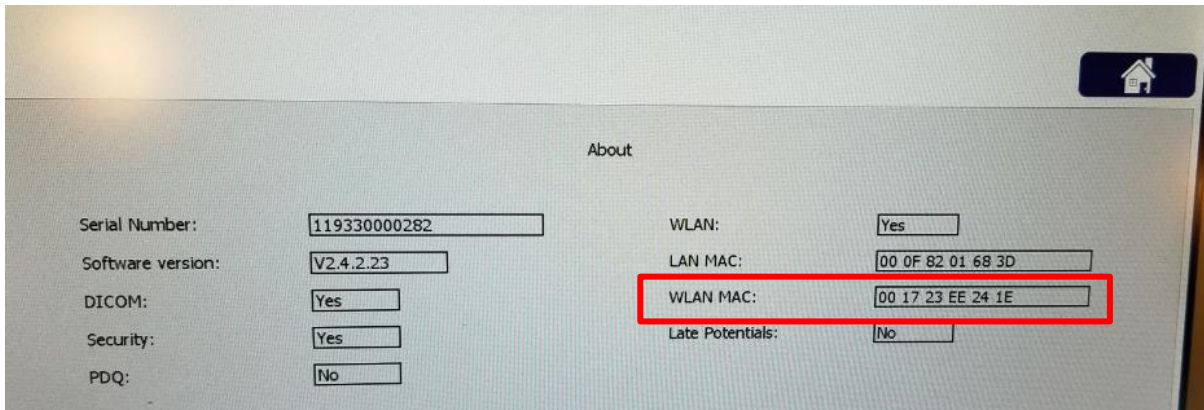
The WLAN MAC address is located under the SETTINGS function of the electrocardiograph and will appear as shown below.

The WLAN MAC address contains 12 characters, where the first 6 characters are used to determine the model of the WLAN module installed. The remaining 6 digits will change with each device and is not relevant. Only upgrade units to v2.4.3 that have the MAC address shown below.

MAC address = 00 17 23 xx xx xx

As noted above, software v2.4.3 is not compatible for B&B modules. **If the MAC address is 00 0B 28 xx xx xx, do not perform the software upgrade.**

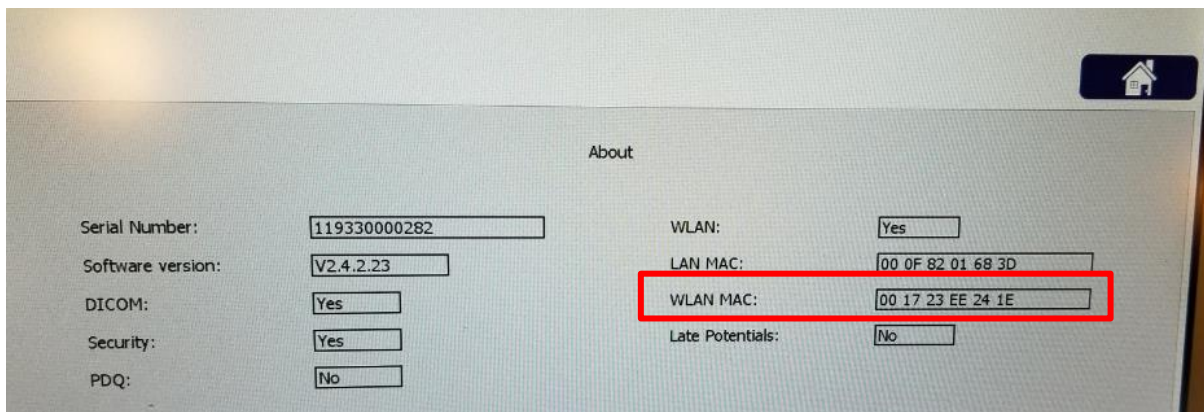
The WLAN MAC address is located under the SETTINGS function of the electrocardiograph and will appear as shown below.

The WLAN MAC address contains 12 characters, where the first 6 characters are used to determine the model of the WLAN module installed. The remaining 6 digits will change with each device and is not relevant. Only upgrade units to v2.4.3 that have the MAC address shown below.

MAC address = 00 17 23 xx xx xx

As noted above, software v2.4.3 is not compatible for B&B modules. **If the MAC address is 00 0B 28 xx xx xx, do not perform the software upgrade.**
