Urgent Field Safety Notice

Subject: Affinity® Birthing Bed (P3600 & P3700 Series) manufactured before 18-Oct-2007

FSCA-identifier: Mod 382

Date: February 18, 2008

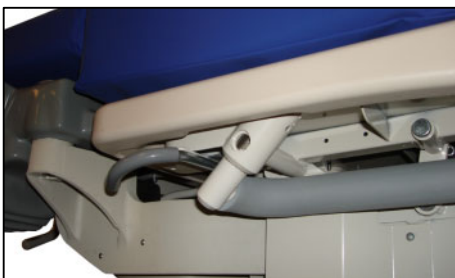
The shear point is created by a 3/8" slot on the labor grip rotation mechanism, which is under the upper surface of the frame near the seat section of the bed inside of the labor grip housing.

Labor Grip without plug

With the labor grip in both the stored and use positions, the slot in the labor grip mechanism is visible through a hole in the labor grip housing. As the labor grip is rotated from the stored to the use position—or vice versa—the mechanism rotates inside the labor grip housing allowing the hole to become open then closed, thus creating a shearing point between the labor grip housing and the labor grip mechanism.

- Hill-Rom will provide a free upgrade kit for all of your Affinity® Birthing Beds. The kit includes two machined plugs per bed to insert into the hole, an insertion tool, and full written instructions to assist in the upgrade of the labor grips. The upgrade kit(s) will be addressed and shipped to your Biomedical/Clinical Engineering department in the near future. **Please complete and return the attached form to facilitate delivery to the correct person or department.**
- The upgrade should be performed on all Affinity® Birthing Beds manufactured before October 18, 2007, by your facility qualified personnel for the performance of maintenance activities. The upgrade should take approximately 10 minutes per bed.
- Upon request, Hill-Rom will provide training and assistance with this correction. In the interim period, you may continue to use your Affinity® Birthing beds.

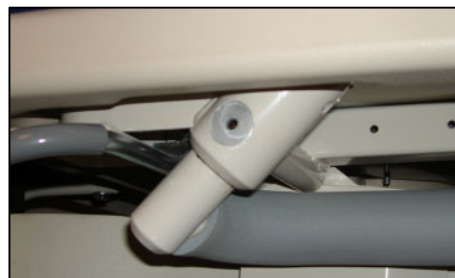
Labor Grip with plug
