**URGENT – FIELD SAFETY NOTICE**  
**Concerto & Basic shower trolley**

<b>Date:</b>	<b>2019-August 12</b>
<b>Product Issue:</b>	Concerto & Basic shower trolley – Potential unintentional drop of safety side panel
<b>Affected Product:</b>	<ul style="list-style-type: none"> <li>✓ Concerto &amp; Basic shower trolleys manufactured between November 2018 and June 2019; Serial number ranges: P0512263 to P0551621 <ul style="list-style-type: none"> <li>• Concerto &amp; Basic shower trolleys fitted with the affected spare parts (safety catch) part no. 8451622, 8546608, S8533571-031, S8533572-031, S8533570-031 S8542201-014, S8523559-031, 100-805-03, 100-806-03 during service between 2019-Nov-27 and 2019-Jun-14</li> </ul> </li> </ul>
<b>Affected Serial No.:</b>	Attachment A
<b>Resolution:</b>	Safety catches replacement in order to ensure the device is operating safely
<b>Field Safety Notice:</b>	FSN-POZ-002-2019
<b>Pages:</b>	3 & Customer Response Form

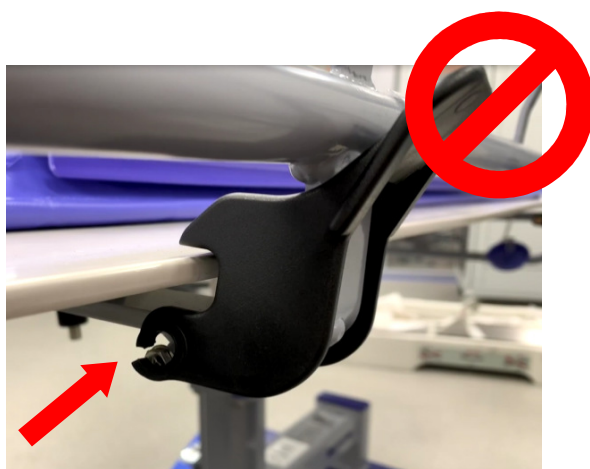
Image 3

Arjo has become aware that any of the 4 Safety Catch(es) may exhibit a mechanical failure (break in one of the arms of Safety Catch), which in certain circumstances may contribute to the Side Support unintentionally opening and may lead to a potential risk of patient fall, leading to possible injuries to patient and/or caregiver.

1. Verify the condition of all 4 Safety Catches attached to your device. If you notice the break (as shown in Image 3) withdraw the trolley from use.

- ✓ It is recommended that the Safety Catches on the shower trolley Side Supports be inspected daily to ensure any of the catches are not broken as show on the Image 3.
- ✓ The patient is not left unattended at any time.
- ✓ The patient is fully assisted so that he/she does not grab, push or lean against the Side Supports during showering activities.
- ✓ Caregivers should limit pulling and pushing of the Side Supports with excessive force.
- ✓ **Note:** always adhere to the Safe Working Load as outlined in the IFU.
